**Subject: Documentation of Environmental Indicator Determination  
Steelcote Manufacturing Company, St. Louis, Missouri**

DOCUMENTATION OF ENVIRONMENTAL INDICATOR DETERMINATION

**RCRA Corrective Action  
Environmental Indicator (EI) RCRIS Code (CA725)**

**Facility Name:** Steelcote Manufacturing Company  
**Facility Address:** One Steelcote Square, St. Louis, Missouri  
**Facility EPA ID #:** MOD006275036

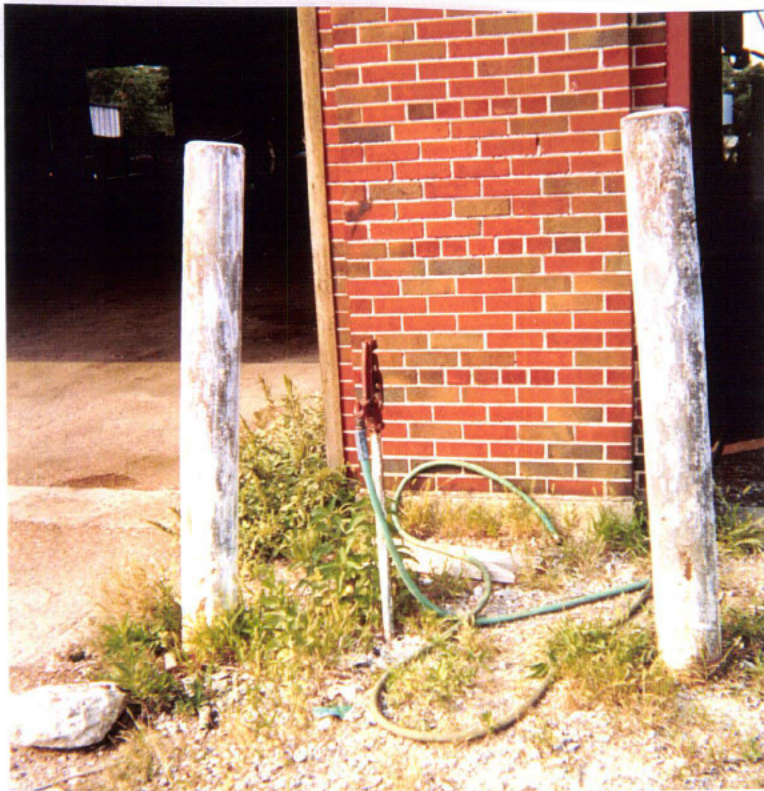
PROJECT NO.	DESCRIPTION	One of two groundwater pumps at 3225 Chouteau Avenue, St. Louis, Missouri.	1
G00991R0781805FR	SITE NAME	Steelcote Manufacturing Company, St. Louis, Missouri	DATE
Direction: N	PHOTOGRAPHER	Jessica Kidwell	09/04/01
